# ENERGY AUDIT

ACTUAL HOME

October 23, 2007

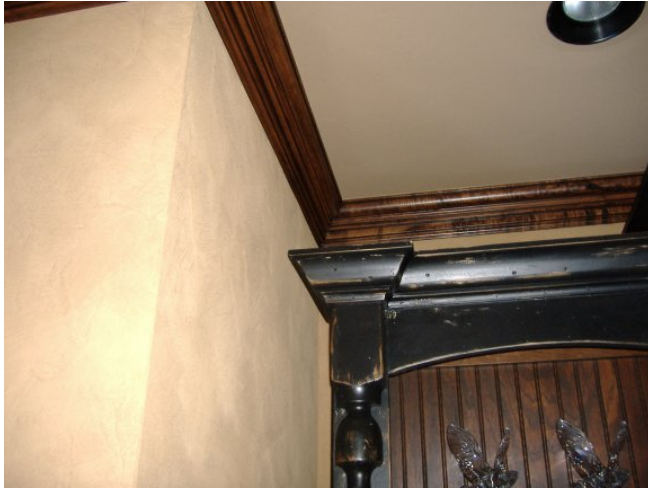
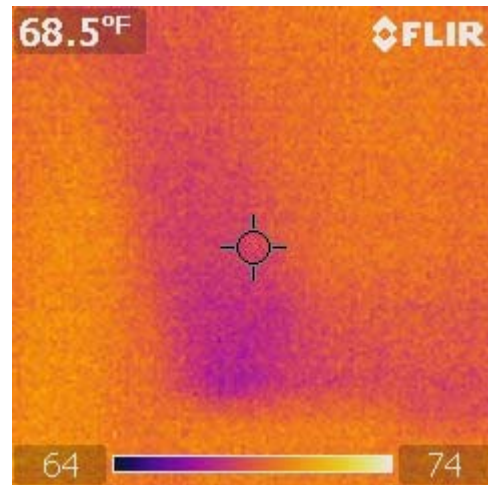
The images above demonstrate heat loss through an unsealed area behind crown molding. There is no need to address this as loss is minimal compared to possible costs of correction.

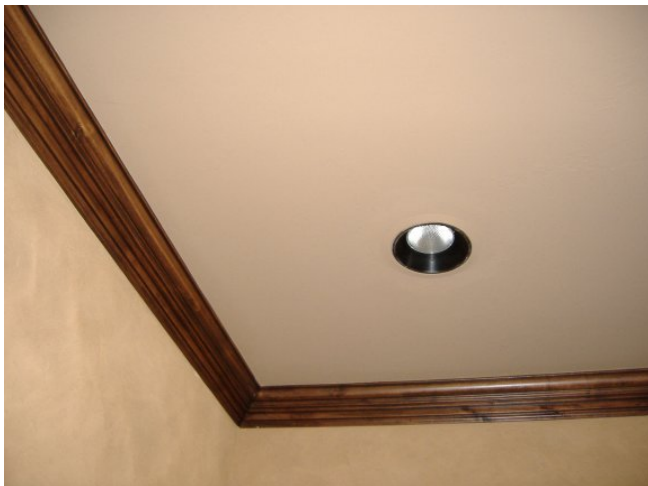
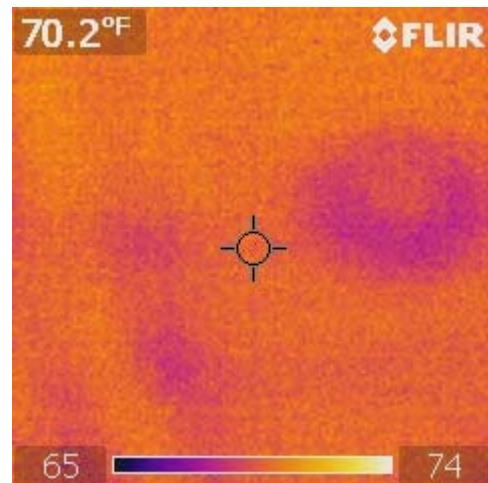
This image shows a recessed light cans being a source of cold air entering the house. Access the light cans of the second floor from the attic. The first floor is a bit more challenging. You probably do not need to do anything, as the costs of correcting the problem will outweigh any possible benefits. Simple change of your incandescent bulbs into compact fluorescents (CFL) bulbs will lower your electric bill.

\* Your light switches, electric outlets and recessed light cans are a major source of air leakage. Light switch and electric outlet boxes could be insulated from behind with special foam boxes. Recessed light cans can be re-insulated from the attic ONLY IF YOU CHANGE YOUR EXISTING BULBS TO COMPACT FLUORESCENT. REGULAR BULBS REQUIRE VENTILATION TO MANAGE HEAT AND AVOID DANGER OF FIRE.

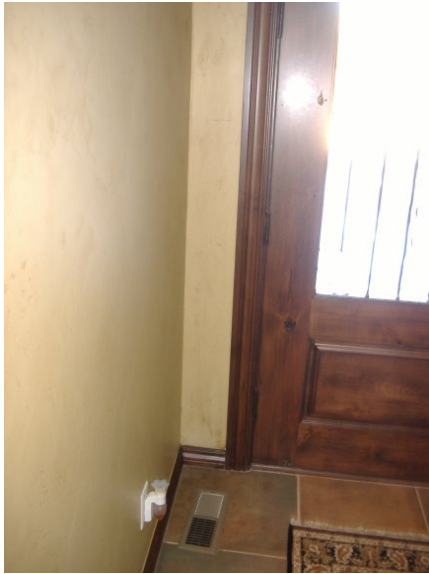
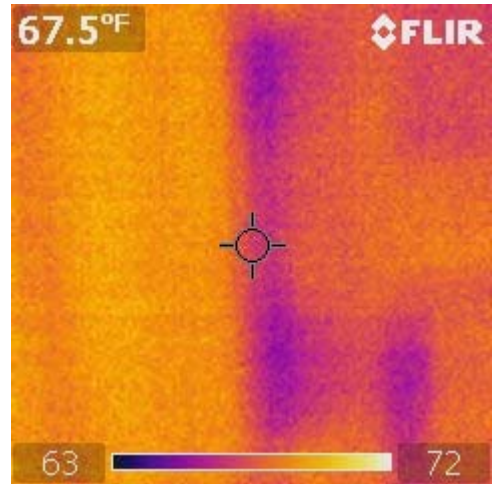
The air leaks around doors are minimal. They allow fresh air access into your house. You do not want your house to be overly tight.

\* We would recommend weather stripping of all doors connecting unconditioned space with inside of the house (main door, door into the backyard, and attic entrance door), and attic access hole. The air leaks on the second floor create a negative pressure by allowing hot air out and pulling cold air in through the leaks of the first floor. Sealing these air leaks should noticeably improve comfort levels for residents. Attaching a piece of insulation batt, and attaching weather strip along the edge of the lid could easily insulate Attic access door. This will create an insulated air sealed door.

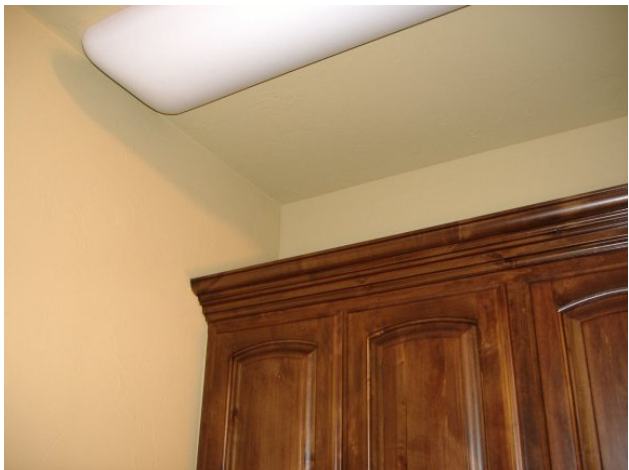
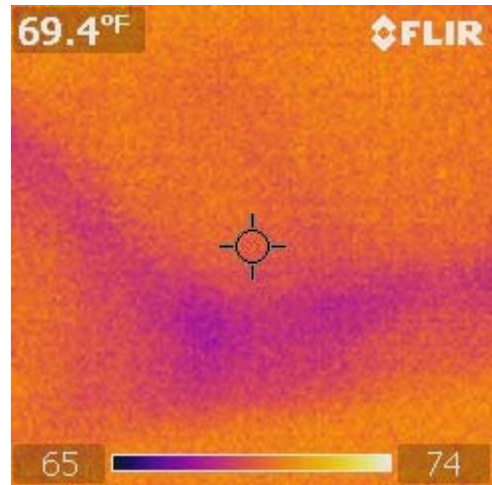
This is another example of sealant missing at the wall-ceiling connection. Not a major problem. Just for your information.

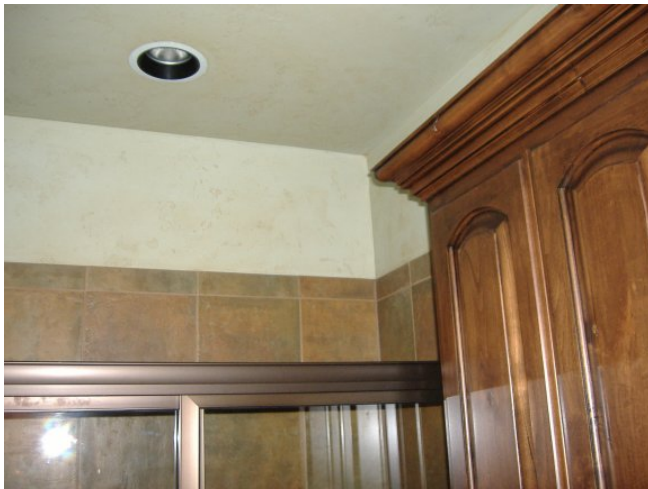
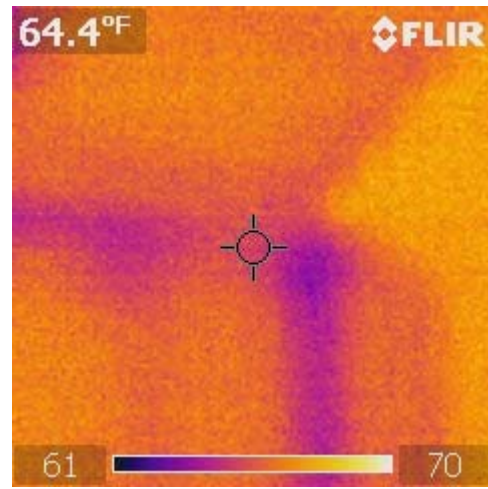
Similar sealant issue. Not a major concern.

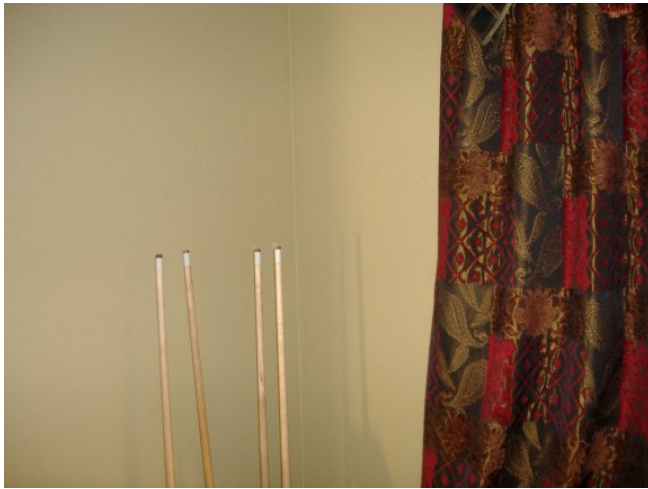
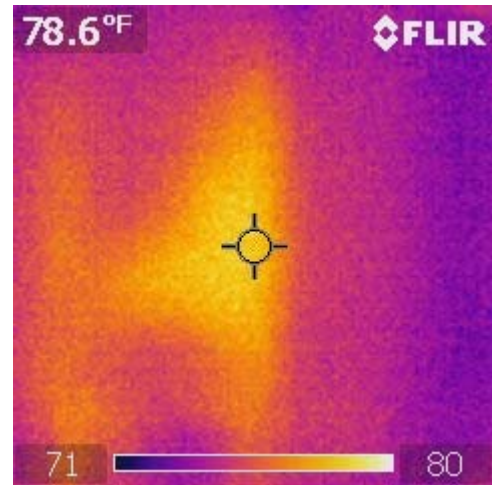
This game room on the second floor gets extra heat through the windows. Window film may address this problem. We have also identified air heat movement within the wall – seen as yellow on image above. Correction of wall seal would not be cost effective.

\* Consider application of special clear window film, which blocks up to 40% of solar and radiant heat, and 99% of UV, which causes fading of furniture and carpeting. Ask Centaurus representative about availability and costs. We can provide free cost estimate on site.

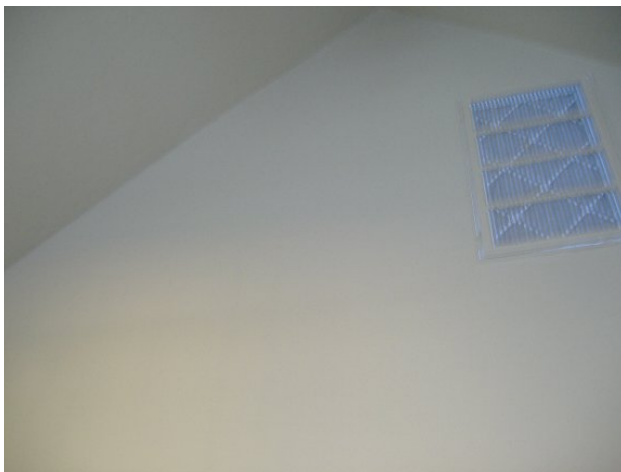
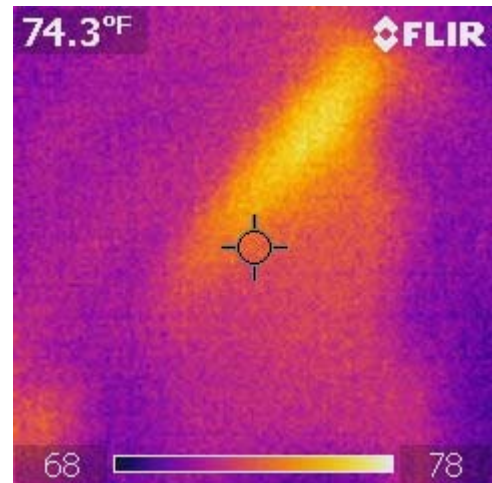
This area requires examining of insulation batt behind this knee wall. The batt needs to be reattached for better insulation.

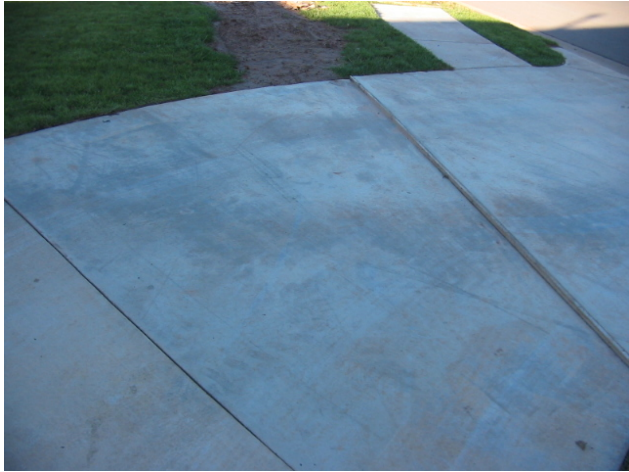
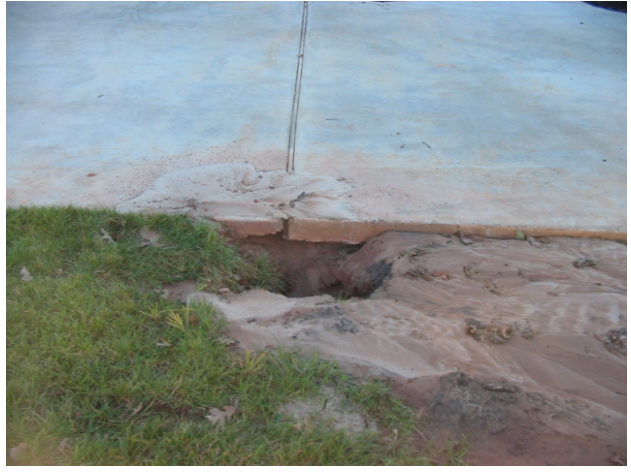
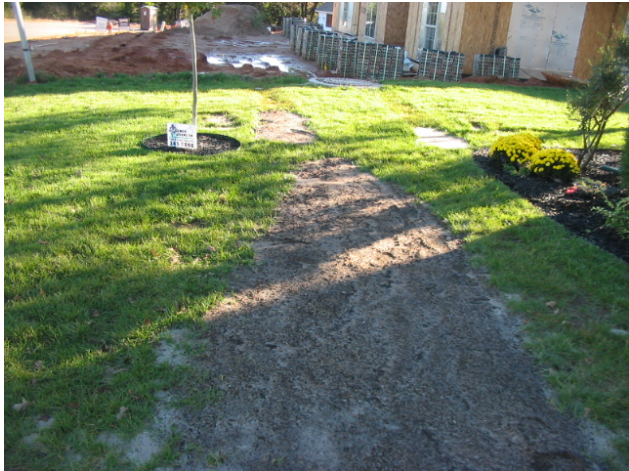
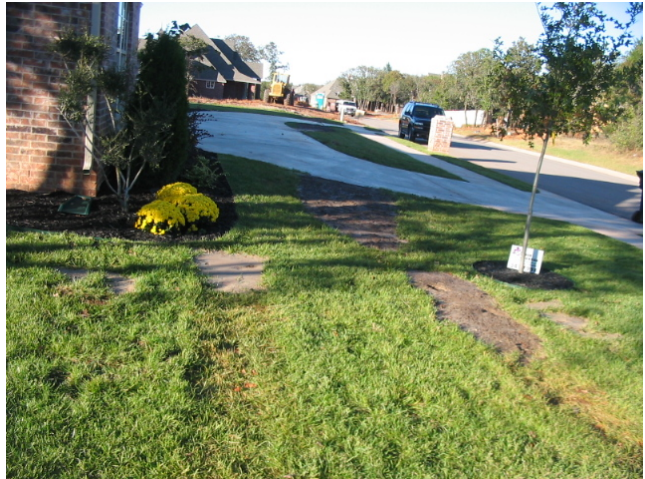
2. My biggest concern is at the front of the property. The soil seems to be washing out under the driveway. I think the problem is the sewer line running along the front, it looks like it was not con-packed and or not back filled correctly. If this is not corrected, the driveway and even the foundation could be damaged.

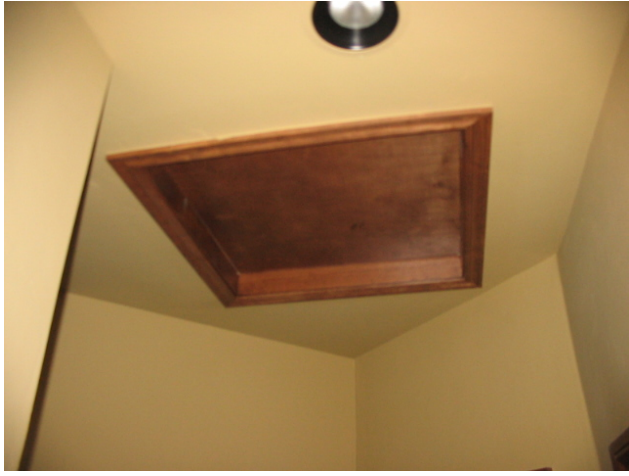
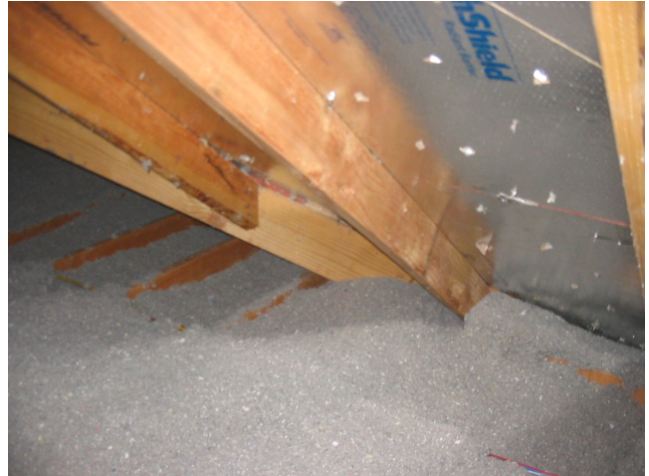
The insulation seems to be in good condition, with a few areas that need to be readjusted in the attic along the 2nd floor hallway. The attic access door needs to be insulated, have batt installed on the attic door.
